Head gasket

Given a terminal case of head gasket failure on a 2002 BMW 316i, **Andrew Everett** tests K-Seal Ultimate head gasket repair.

K-Seal head gasket repair

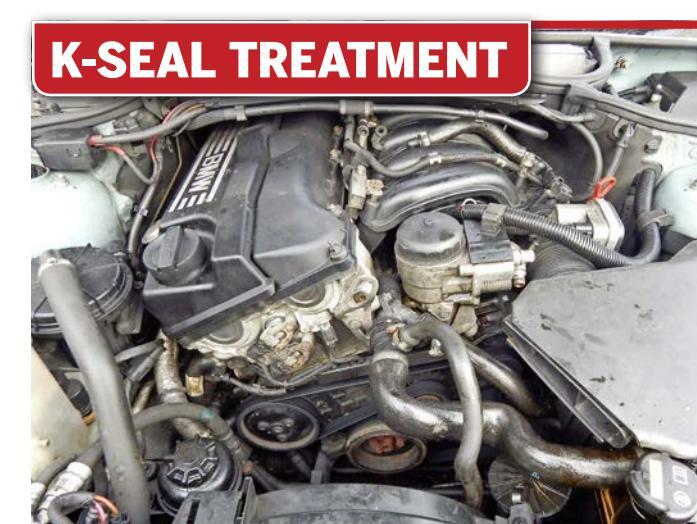
Here is the N42 engine. It's pretty oily, but it starts on the button and sounds OK. It isn't overheating, but we still need to replace a lot of the cooling system.

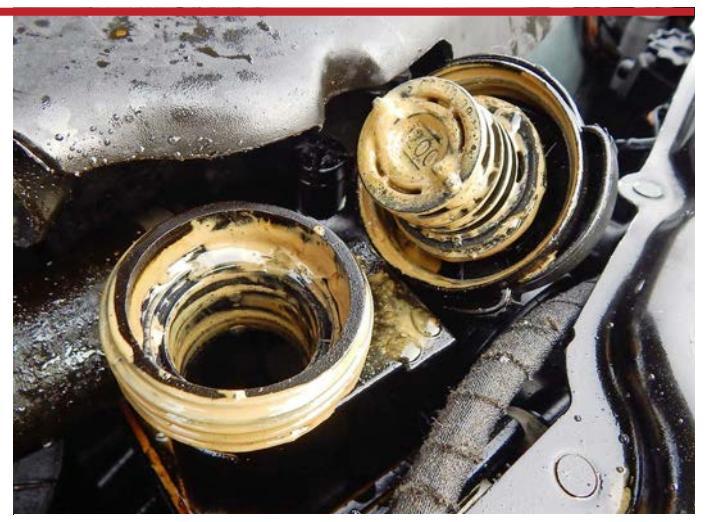
2 Removing the coolant header tank cap reveals that oil has entered the cooling system, resulting in this dreadful emulsion. However, the engine oil is the right colour, so it has not been contaminated.

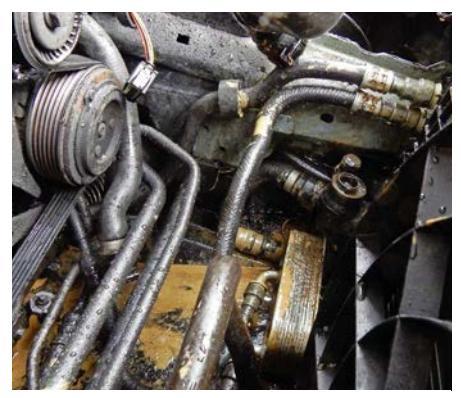
3 It's clear the system has been pressurising, because when the radiator cap was removed, the emulsified gunk spilled over. It looked better following a blast with a pressure washer.

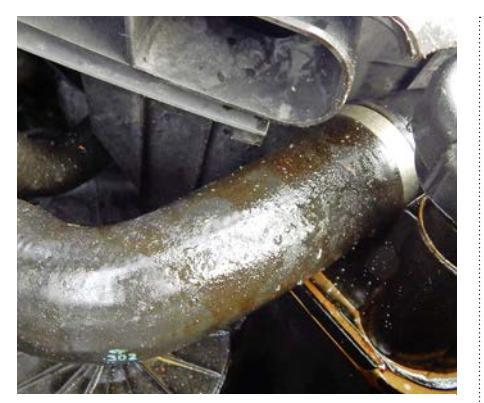
4 We needed to replace the top coolant hoses as the oily emulsion in the top hose had soaked though and rotted the rubber. When it got hot enough, pressure in the system would have blown it apart.

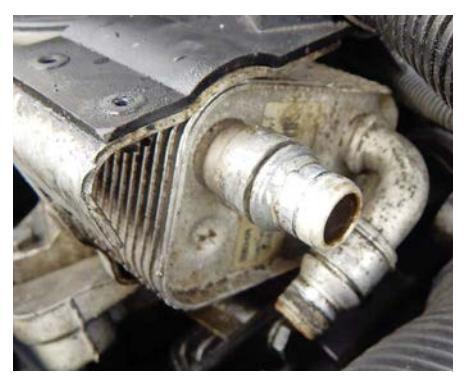
5 The coolant-to-oil heat exchanger is bolted to the oil filter housing with four Torx screws. There is a rubber gasket between it and the filter body, but that rarely fails and won't result in a cross-leak – that's caused by a small internal split in the unit.

The N42 has one possible source of oil-to-water contamination: the heat exchanger fitted to the side of the oil filter housing. These can rupture internally, allowing pressurised oil into the coolant on a cold start. On our car, we disconnected the two coolant pipes from the exchanger – these have those annoying push-fit hoses rather than traditional hose clips. There was no oil seeping from the exchanger, but given that both coolant pipes to it were rotten, we cut off their ends and joined them with a bit of plastic pipe, then ran the engine for 10 minutes. There was no oil leak from the heat exchanger.

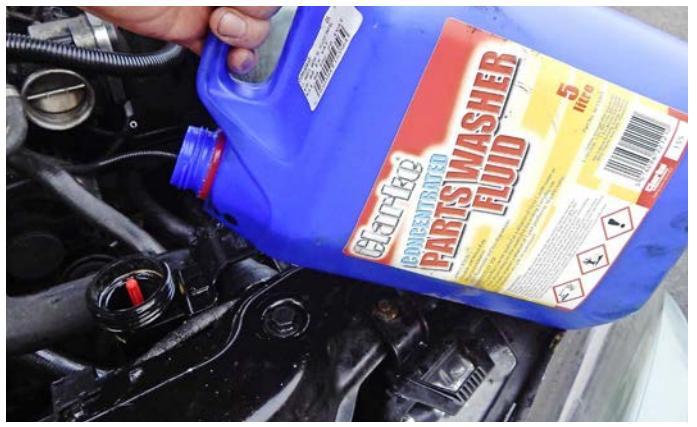
6 The worst of the gunk is flushed from the header tank and five litres of parts washer fluid poured into the header tank. The engine was run for 10 minutes with the heater set to ' Hot' to clean it out, then it was allowed to cool, drained and flushed out with a hose.

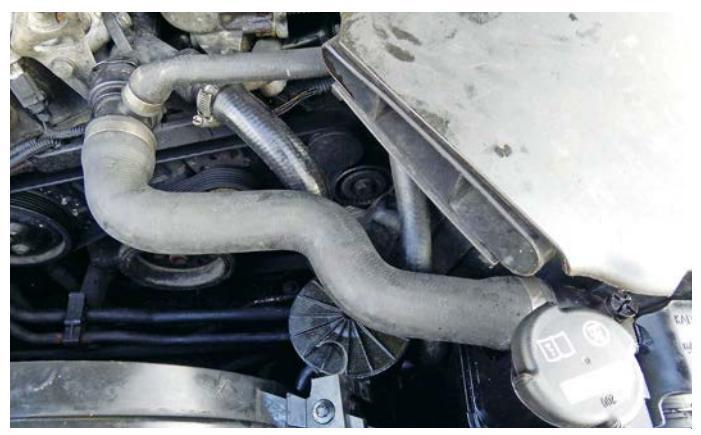
The old header tank was replaced with a newish one along with a secondhand top hose assembly. The header tank clips onto the side of the radiator – smear the rubber seals with washing-up liquid on refitting to make sure it's easily removable if you need to replace in the future.

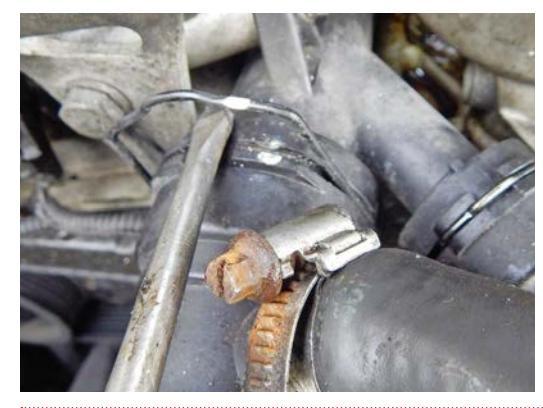
8 ABWW has used this quickrelease hose clip since 1998 on most models – they can be a real pig to remove. The one securing the base of the header tank to the rad stub has a plastic tang on the end so that it can be pulled sideways.

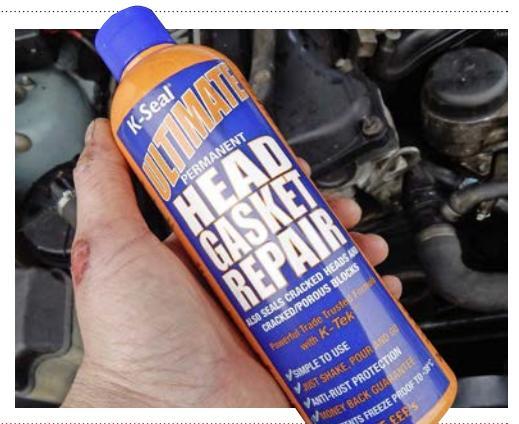
K-Seal isn't like Radweld and won't block a heater matrix. It's a viscous fluid containing copper particles and ceramic microfibres that can block a hole up to 0.635mm. Engine heat will cure the mixture, but will it fix our head gasket?

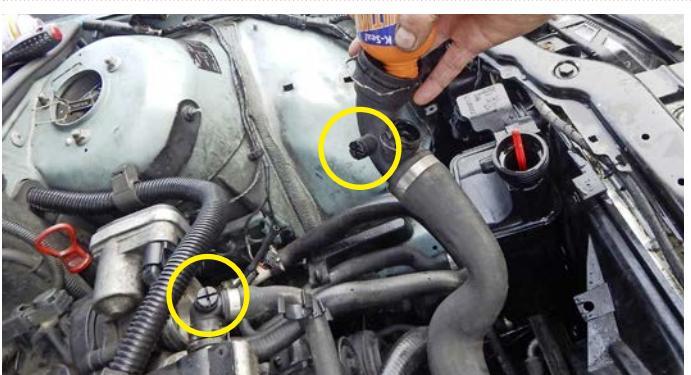
10 We wash the system through with water and washing-up liquid before a final cold water flush, then pour the K-Seal down the top hose. You can see one bleed screw on the coolant elbow and there's another on the small hose near the throttle body (circled).

We disconnected the top hose and poured in the K-Seal, before reconnecting, starting the engine and adding some antifreeze. We held the engine at 2500rpm until the heater began to blow warm air.

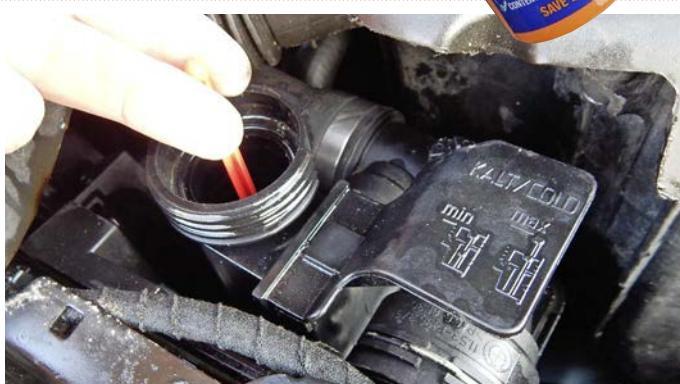
Remove both bleed screws and slowly pour antifreeze into the header tank until the red level sensor stick is raised (as shown). We added four litres, topped up with clean water, started the engine and bled the system. When the heater is blowing warm air, it's bled.
